FIFTEENTH ANNUAL REPORT

WATER COMMISSIONER

FOR THE YEAR ENDING
JANUARY 31, 1910

CITY OF BOSTON
PRINTING DEPARTMENT
1910

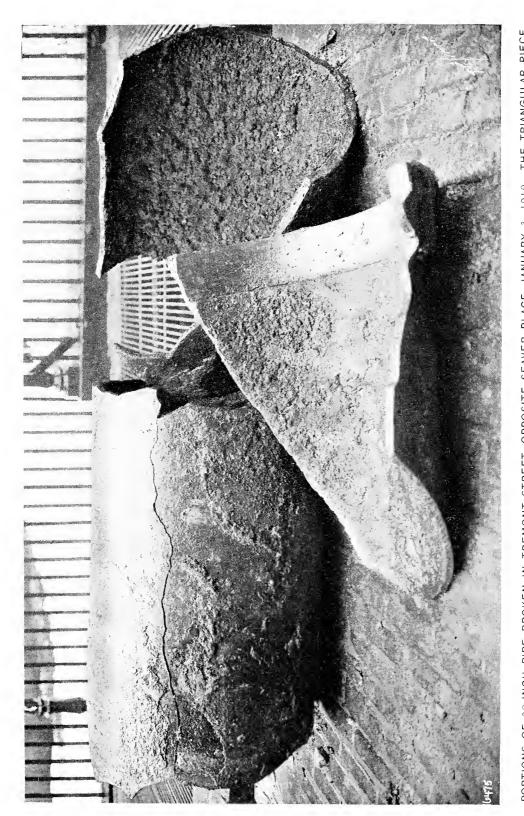
Theaters, the water accumulated to depths of from two to five feet. The performances at all three theaters were prevented, and it was only by the most energetic work on the part of the department that the water was removed and conditions improved so as to allow a resumption of business. At the time the department received notice of the break the emergency automobile and its crew was out answering another call; a delay of about eight minutes occurred on this account, but once upon the spot the gates were closed as quickly as possible. Two 30-inch and one 16-inch gates are all that are necessary to control the line at this point, but as the westerly 30-inch line runs parallel within a few feet distant it was necessary to close the gates on that line before it could be determined which line was broken. Two additional 30-inch gates, therefore, were operated. All this was done in eighty minutes from the time the notice was received at department headquarters. It was a bitter cold night and succeeding day, and the work of removing the water from the cellars and making repairs proceeded with difficulty. We were handicapped by a lack of efficient pumping apparatus, and I wish to say here that, if the department expects to cope successfully with breaks of a similar nature, it will have to provide itself with an equipment of power pumps. The ordinary hand diaphragm pump is practically of no value in emergencies of this nature. The cause of the break was the concrete placed over a sewer and under our pipe. This faulty condition was created when the pipe was shifted to the east in 1896 to make room for the arch of the subway. The concrete was not laid for the entire distance under our pipe. It was placed just at the point of fracture and it was the uneven resistance combined with natural settlement that produced the break.

PORTIONS OF 30-INCH PIPE BROKEN IN TREMONT STREET, OPPOSITE SEAVER PLACE, JANUARY 3, 1910. THE TRIANGULAR PIECE IN FOREGROUND WAS BLOWN OUT. THE CRACK IN LARGE PIECE RAN THE WHOLE LENGTH OF PIPE (9 FEET). THE PIPE WAS LAID IN 1848. (See Page 49.)
